Crossing the Delaware for Transportation Independence: Improving Bicycle and Pedestrian Access to the Benjamin Franklin Bridge

Bicycle Coalition of Greater Philadelphia

June 2010

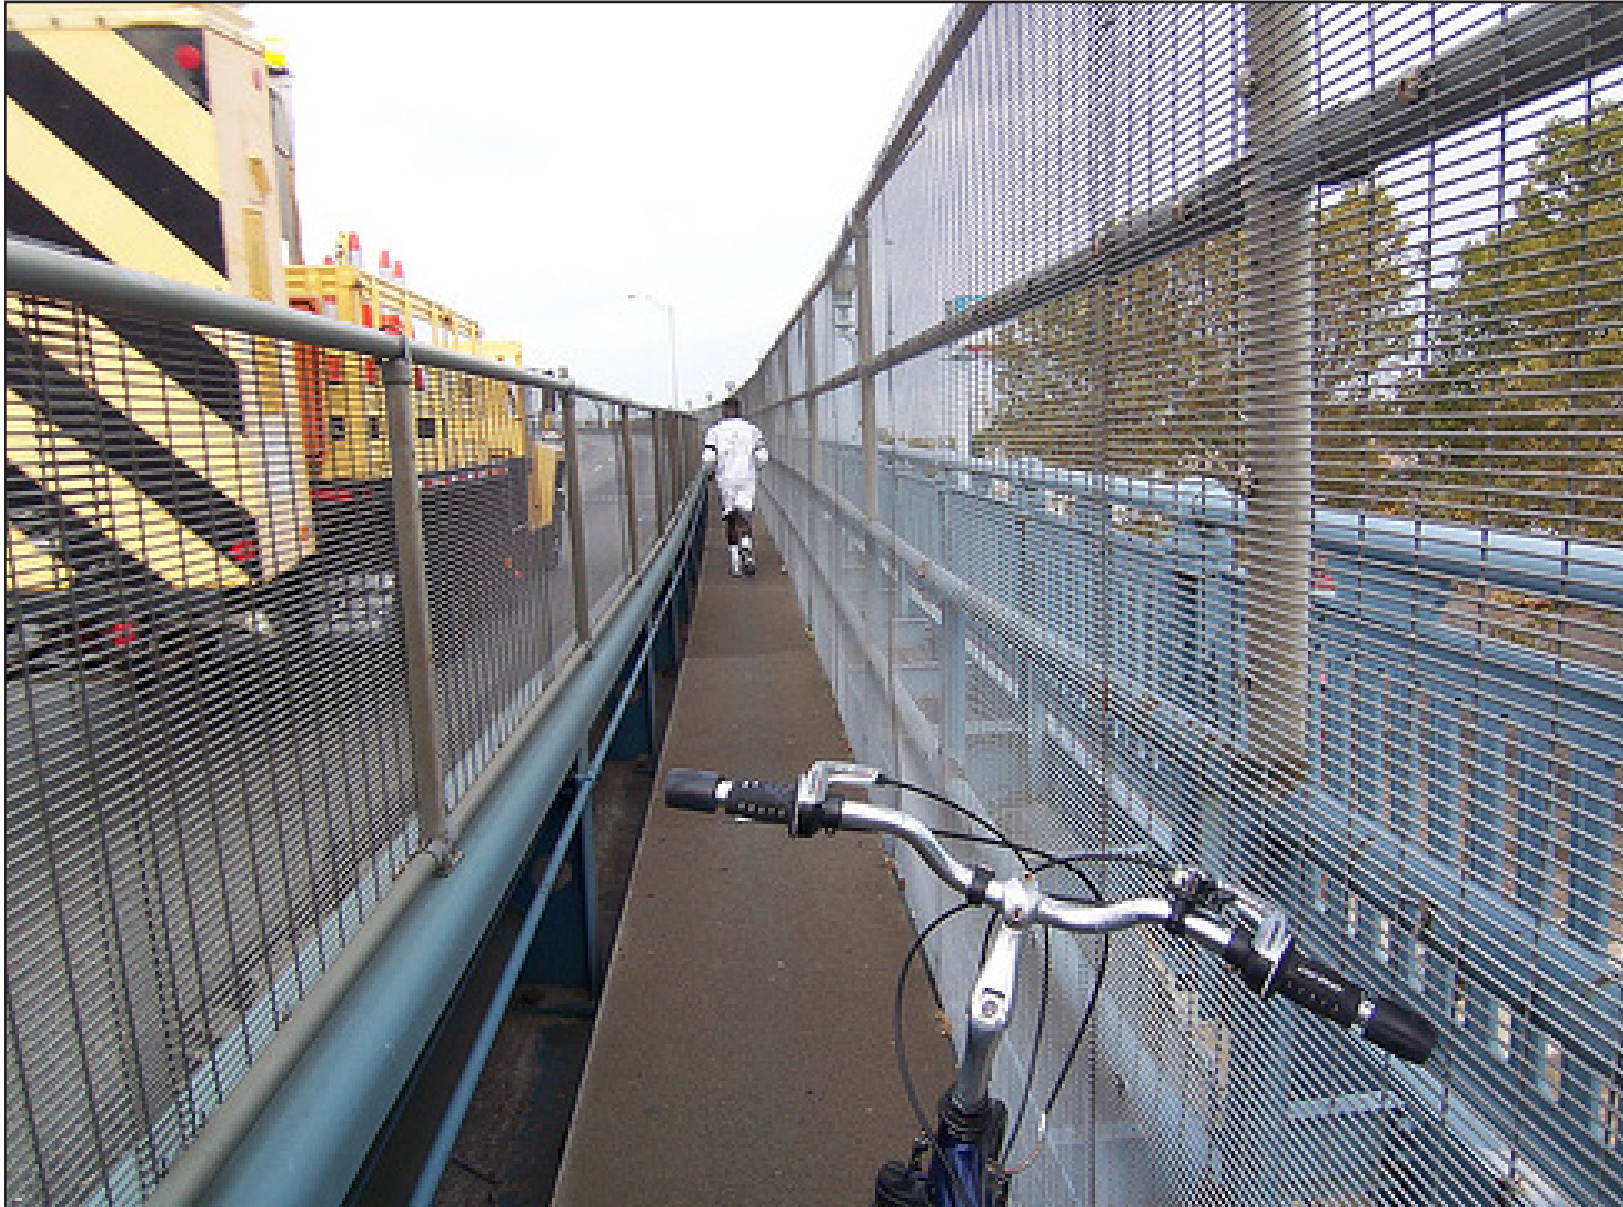
The final portion of the North walkway is a 3 1/2 foot wide “catwalk” leading to the Camden stairway. This narrow passage, known locally as the “Cattle Chute,” is so narrow and confining that it is an impediment for use. It is impossible for two bicyclists or pedestrians to pass each other.; one person must back up to let the other one pass.

The North walkway,
or “cattle chute”

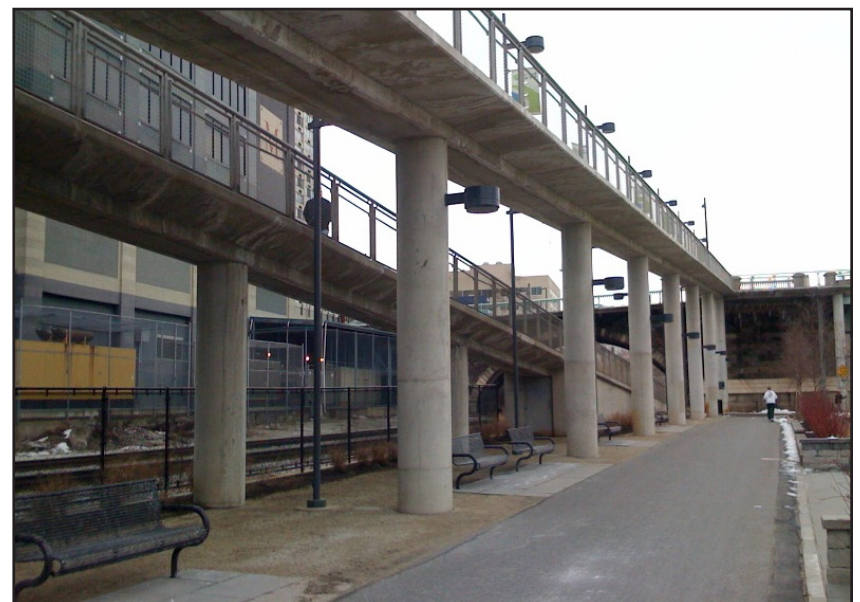
Schuylkill River Valley Path connection to Street Level

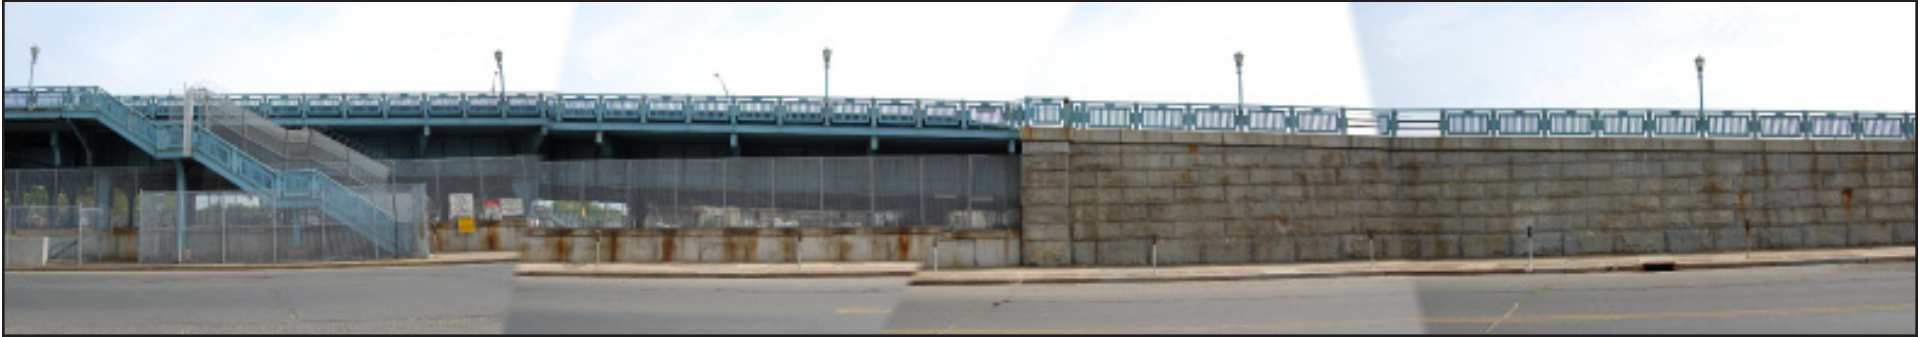
The existing south walkway landing at 4th Street in Camden is a three-story staircase, which is not accessible to bicycle or wheelchair users.

Accelerating and coordinating the construction of an ADA accessible ramp to replace the current south walk stairs would make a significant difference to improving access to and from the Ben Franklin Bridge. Currently, DRPA's Capital Program (dated 2010) has allocated \$3 Million for the walkway to be spent starting in 2012. It would be a missed opportunity to finish the Pearl Street improvements without simultaneously improving access to the Bridge. The lack of an ADA accessible ramp after February 2012 will accentuate the gap that will continue to exist between Camden and Philadelphia even after the expenditure of TIGER funds. The following page illustrates two potential ramp alignments.

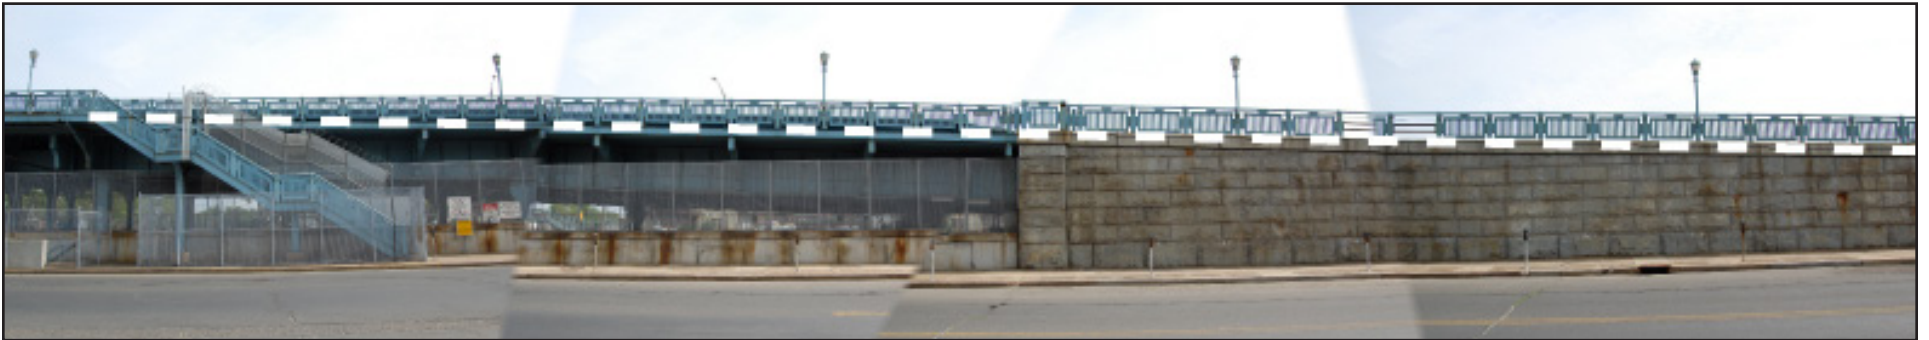
Alternative 1: The white dotted line shows a gentle extended walkway that could run to the end of the bridge near 5th Street and land in a welcoming gateway at Rex Place on the Rutgers Camden campus.

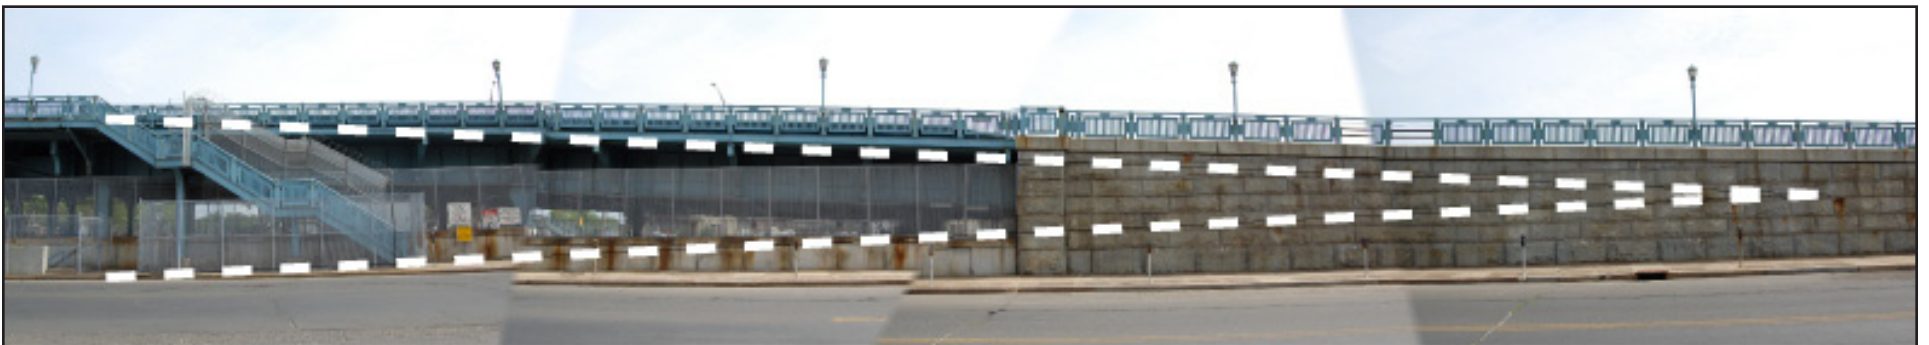
Alternative 2: A somewhat steeper ramp could run for a few hundred feet and switch back to 4th Street. This approach is similar to the Walnut Street landing to the Schuylkill River Trail in Philadelphia.

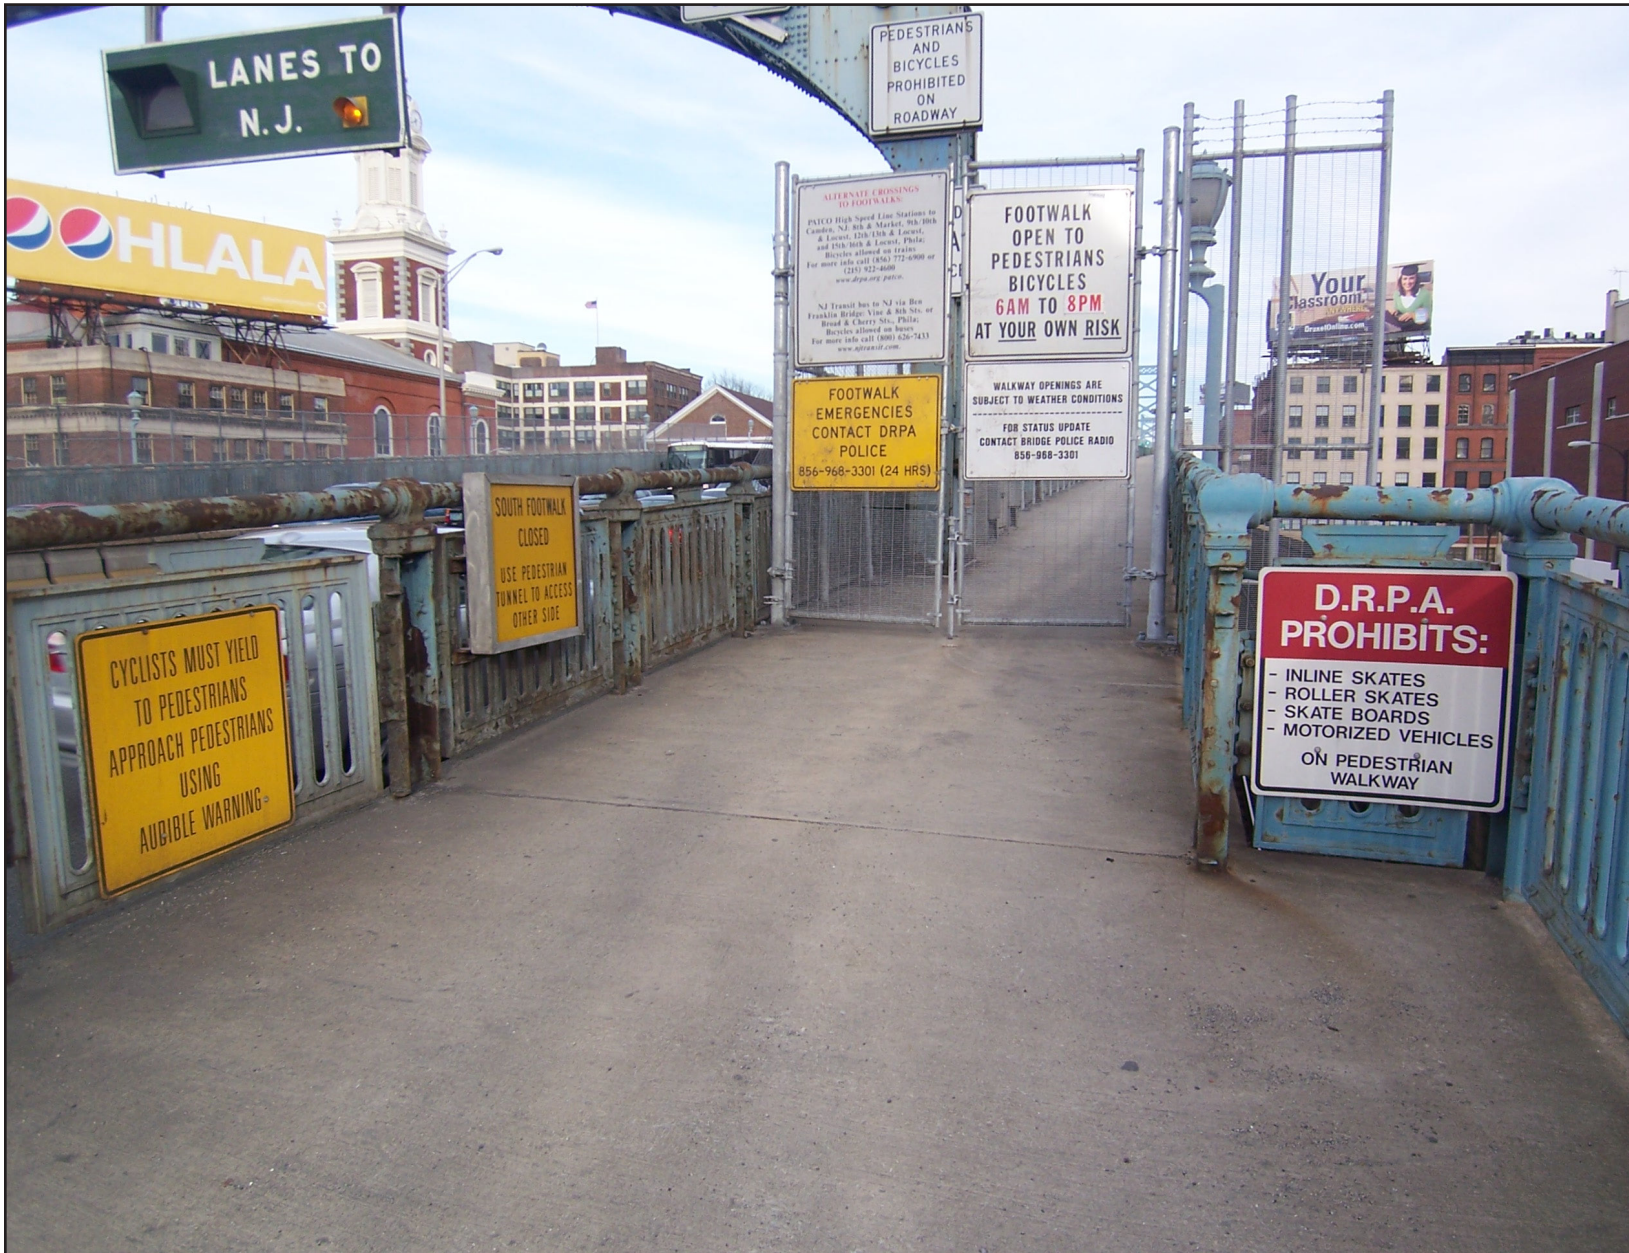
The south entrance on the Philadelphia side of the Benjamin Franklin Bridge Walkway is shown closed for maintenance. The DRPA can consolidate the overwhelming number of signs.

Currently, entrances to the walkways on both sides of the Delaware are covered with with razor wire and anti-scale perimeter mesh fences. The area is crowded with a number of warning signs; the overall effect is unwelcoming and intimidating for new users. (See photo on page 14.)

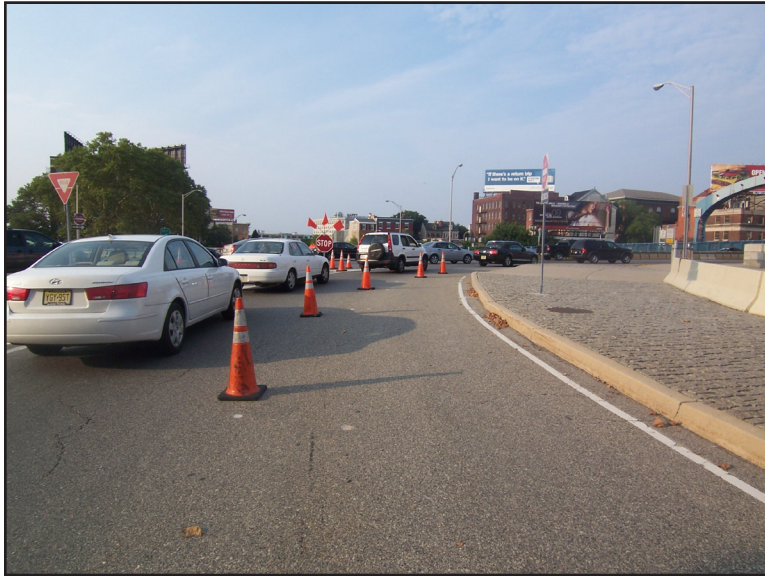
Above: 5th Street approaching the south walkway

Approaching from the 5th Street bike lane, traffic cones are placed in the street to force motor vehicle traffic to merge. The configuration is hazardous for bicycles because the cones create a pinch point at the merge where bicycles must run up the curb cut to access the walkway or the pedestrian tunnel. Westbound cyclists must ride downhill on a belgian block sidewalk to access 4th Street. Meanwhile, those coming uphill from 4th Street are discouraged by a “For Official Use Only” sign before reaching the Walkway approach.

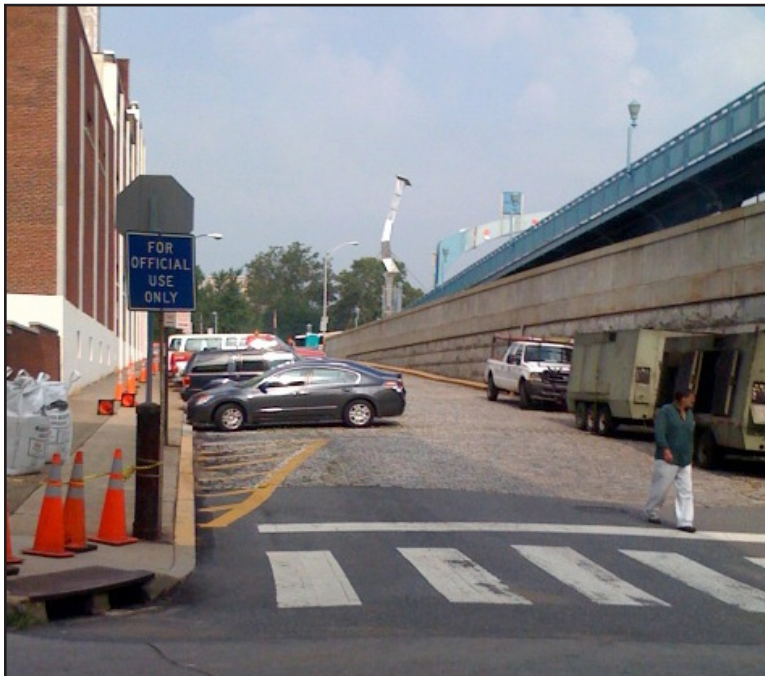
Below: “FOR OFFICIAL USE ONLY” sign on 4th Street Approach to Walkway

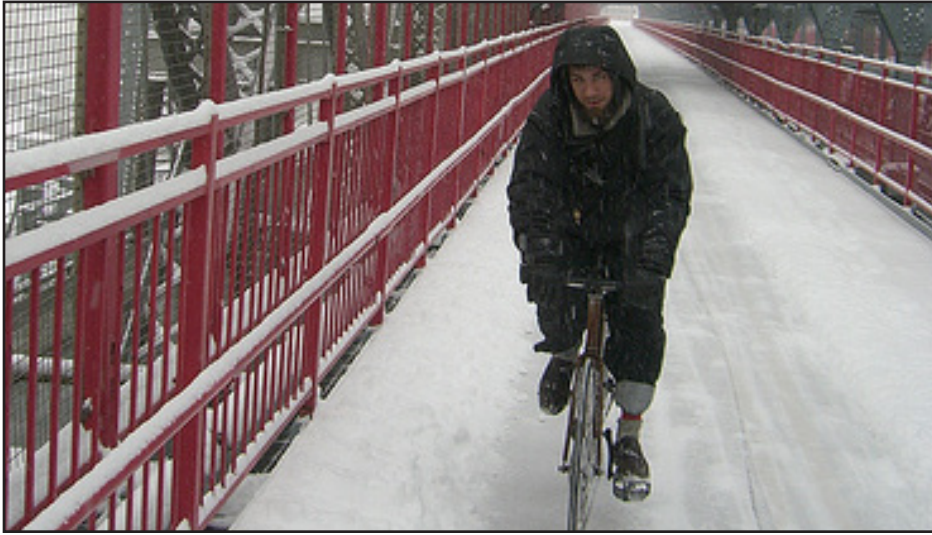
The Williamsburg Bridge walkway open during a snow event.
Photo from Blind Robert's Photosteam on Flickr:
<http://www.flickr.com/photos/blindrobert/2344836800/>

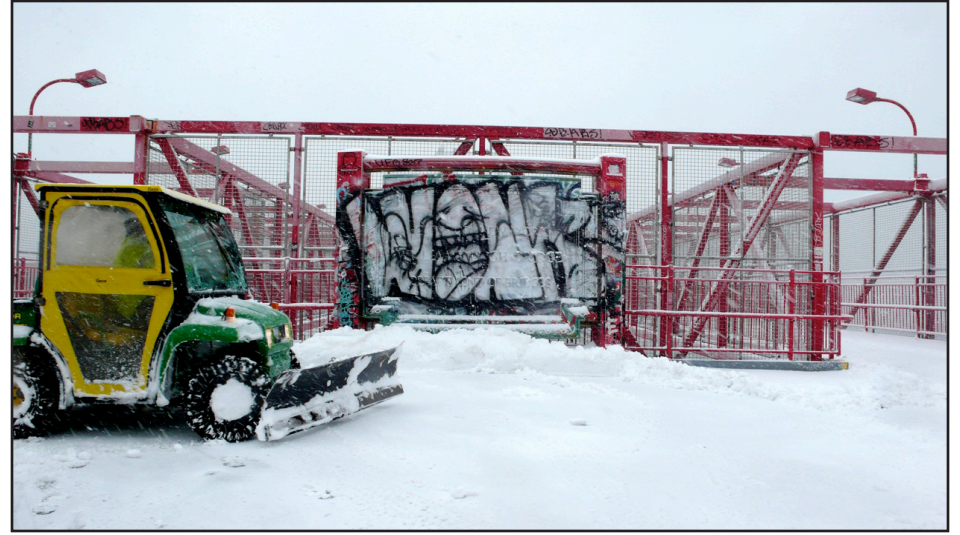
A Williamsburg Bridge walkway plow at work after a snow event.
Image from TheJamesC's Photostream on Flickr:
<http://www.flickr.com/photos/thajimc/4346111043/sizes/o/in/photostream/>

Other bridges of similar design have found ways to clear the walkways without closing them after winter weather events. The New York City Department of Transportation (NYCDOT) is responsible for removing snow on pedestrian walkways adjacent to bridges.

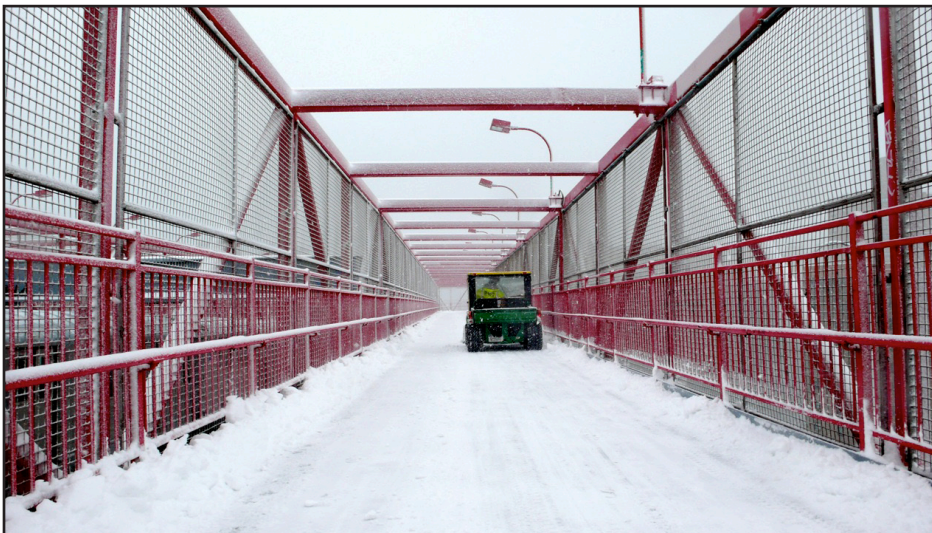
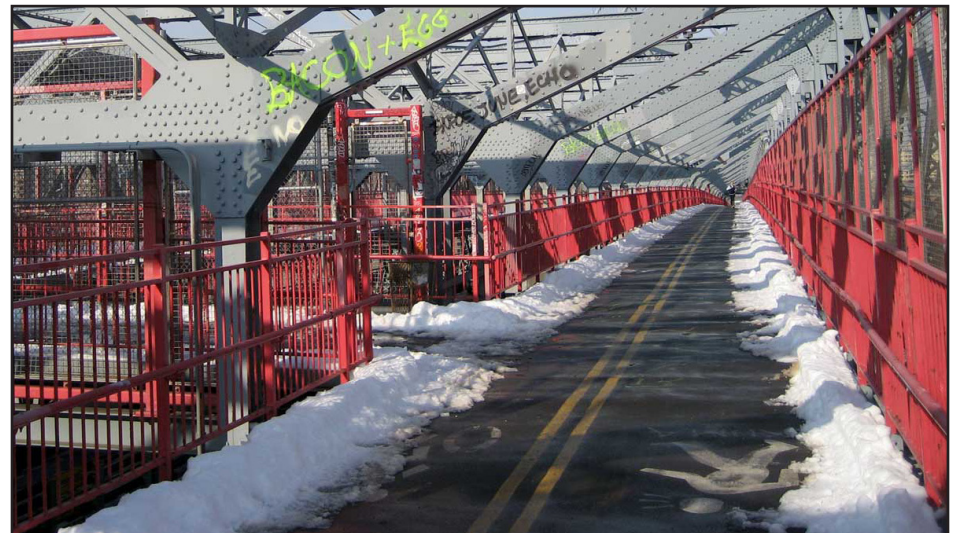
The Williamsburg Bridge plowing and open after a snow event.
Image from TheJamesC's Photostream on Flickr: <http://www.flickr.com/photos/thajimc/4346110929/in/photostream/>

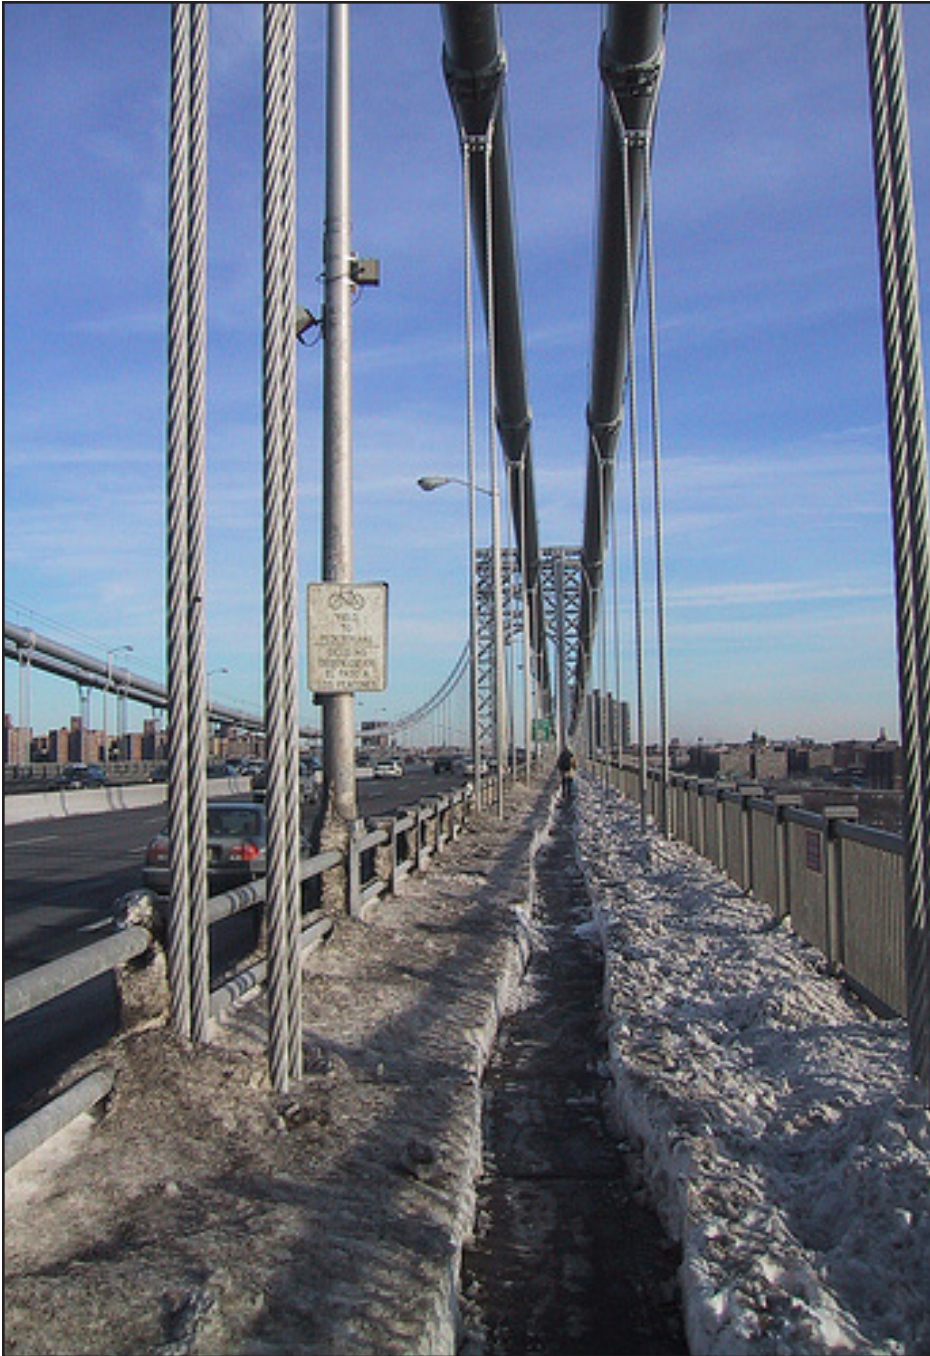
The George Washington Bridge, open and plowed, after a snow event.
<http://www.flickr.com/photos/promaine/561792780/>
